A decade of fluvial morphodynamics: relocation and restoration of the Inde River (North-Rhine Westphalia, Germany)

Abstract

Keywords: River relocation, River restoration, Fluvial morphodynamics, Heavy metal tracer, Fine sediment transport, Morphodynamic equilibrium

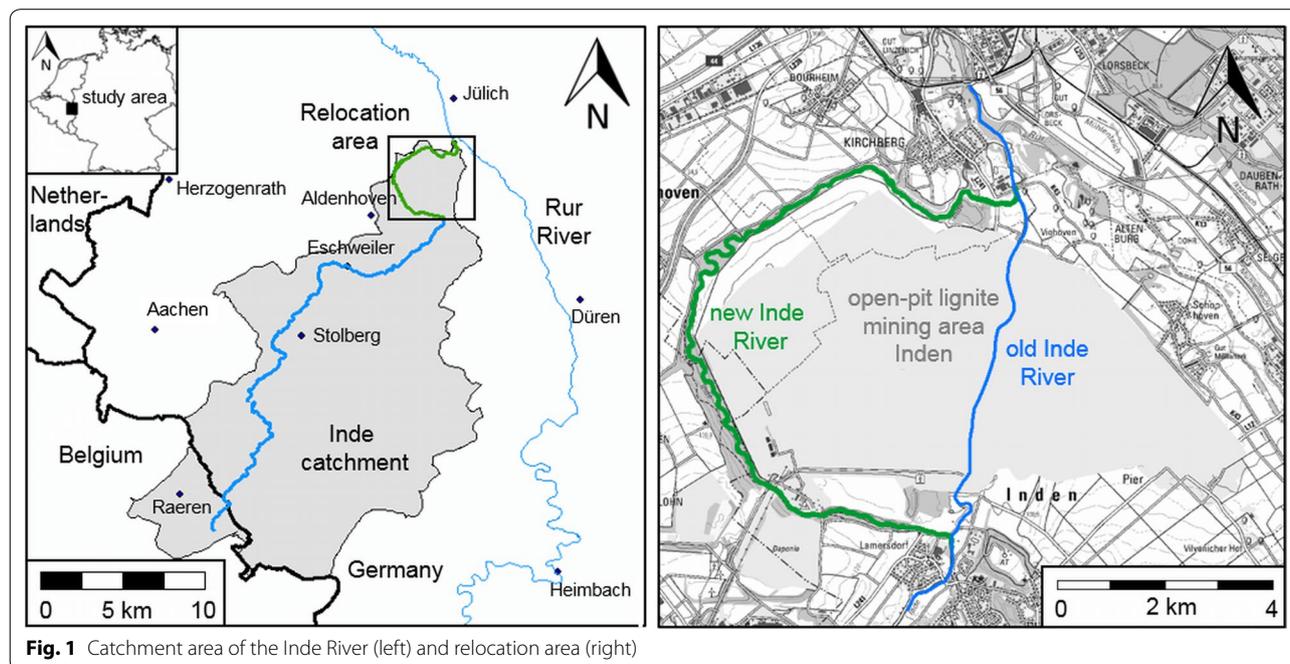
Fig. 1 Catchment area of the Inde River (left) and relocation area (right)

Until 2005 AD, the lower reaches of Inde River flowed through the prospective extraction field of the open-pit lignite mining area Inden, which belongs to the Rhenish lignite-mining region in Western Germany between the cities of Aachen and Mönchengladbach (see Fig. 2). A -km-long reach of the Inde River (old Inde River) was relocated as the consequence of the progressing open-pit lignite mining towards a 12-km-long river reach (new Inde River). The relocation includes different restoration interventions. The project was finished in 2005 AD, and the system was hydraulically connected to the existing river reaches upstream and downstream (see Fig. 1).

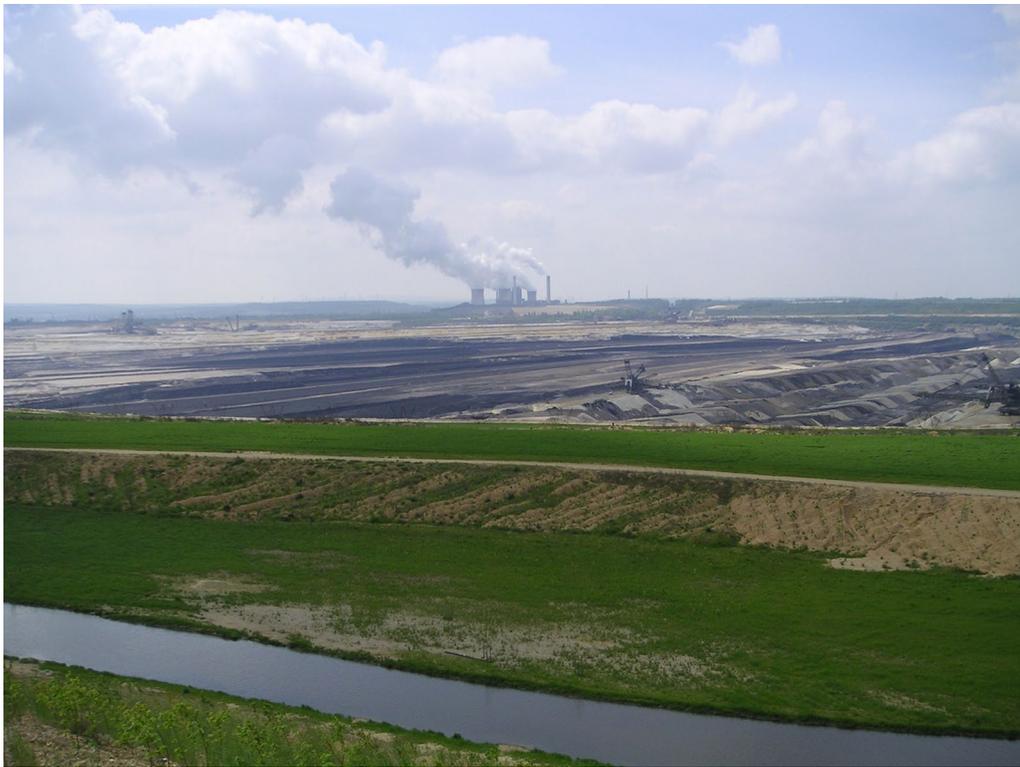
Fig. 2 Open-pit mine Inden with the Inde River (foreground) (Photo: IWW, RWTH Aachen)

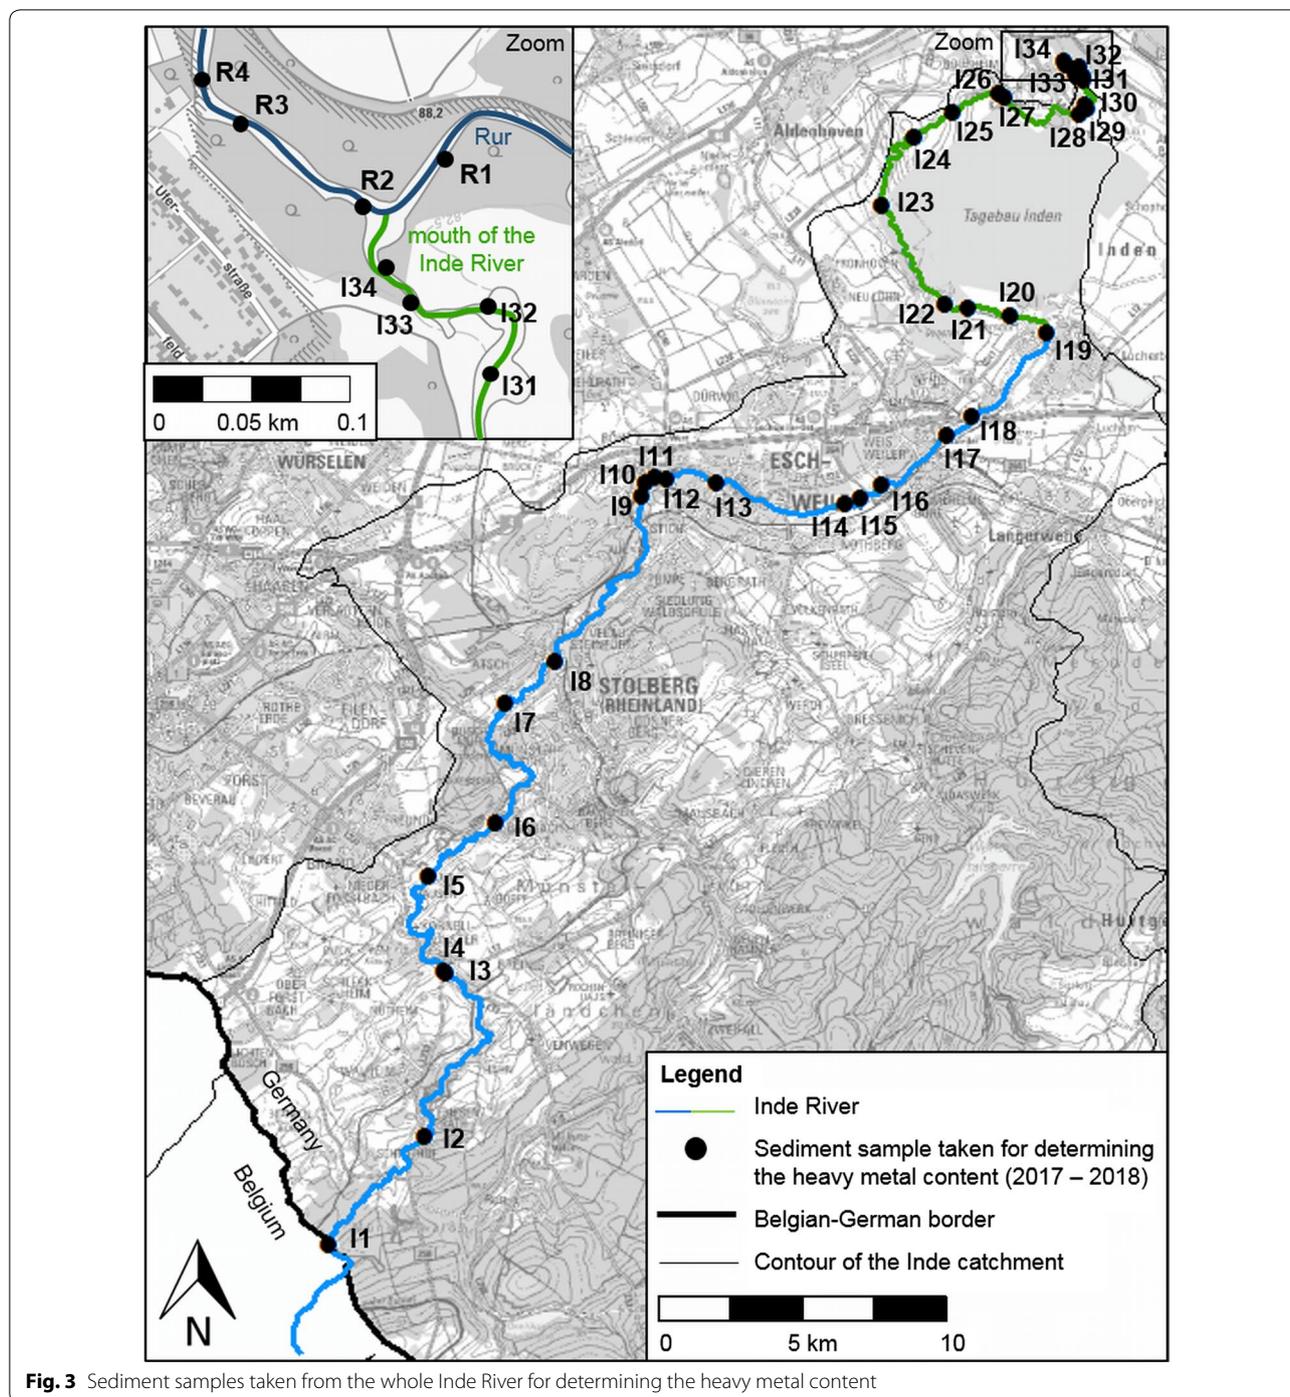
Fig. 3 Sediment samples taken from the whole Inde River for determining the heavy metal content

River (see Fig. 3, samples R1–R4). The composite samples of the upper 20 cm were sampled using a riverside auger (stainless steel) with a diameter of 6.5 cm. The samples of the surface layer were sampled using a cone-shaped pot (height: 24 cm, diameter of opening: 14 cm, stainless steel).

sampling site as I19, see Fig. 3). This sample was treated like the samples taken with the method after [40].

The results of the suspended sediments collected during bankfull discharge upstream of the restoration (same sampling site as I19, see Fig. 3) show concentrations of 2510.5 mg/kg zinc, 692.7 mg/kg lead and 124.4 mg/kg copper. These concentrations are higher than those observed in the sediment samples of the surface layer from the new riverbed. Surface layer sediment samples I20 and I21 show higher concentrations of heavy metals in contrast to samples I22–I27 (see Fig. 13). Samples I20 and I21 are closer to the old Inde River. The corresponding longitudinal profile of heavy metal concentrations between sampling sites I20 and I24 shows a slight decrease. The concentrations of samples I26 and I27 are higher and are comparable to those of sample I23 (see Fig. 13, samples I20–I27). Samples I26 and I27 belong to subdivision G (see Fig. 11). The available data show that

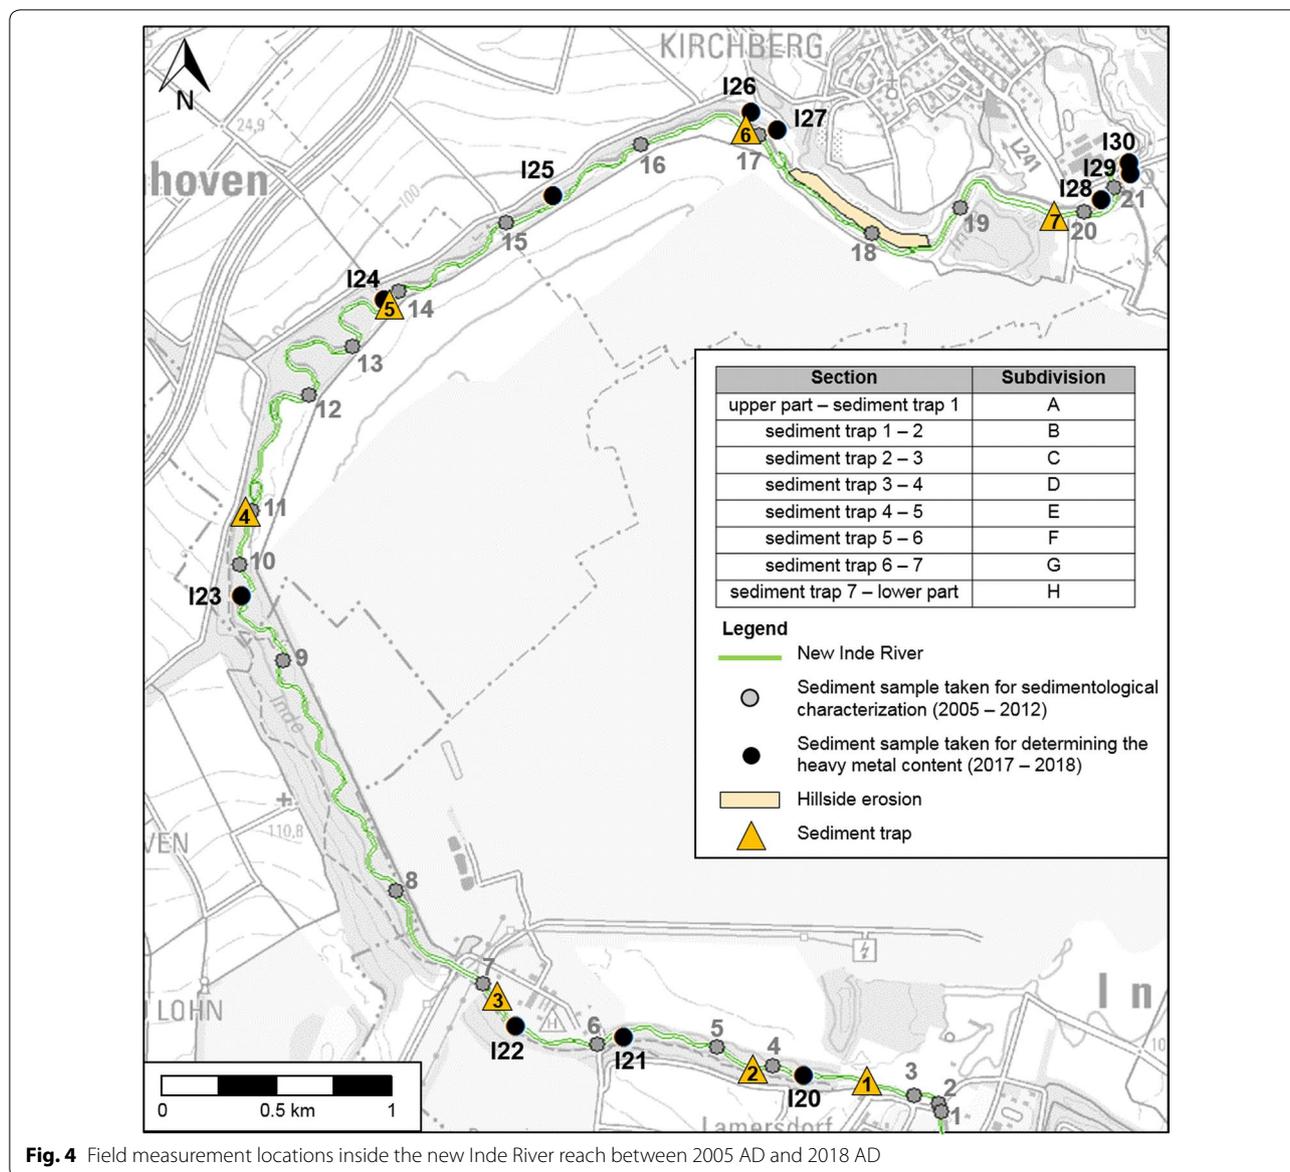
During the construction phase, seven structurally identical sediment traps were installed in the new Inde River reach (see Fig. 4). Sediment traps are basin-shaped extensions or depressions located in the river, which are permanently passed through by water and sediment [35]. Such a sediment trap traps incoming bed load and

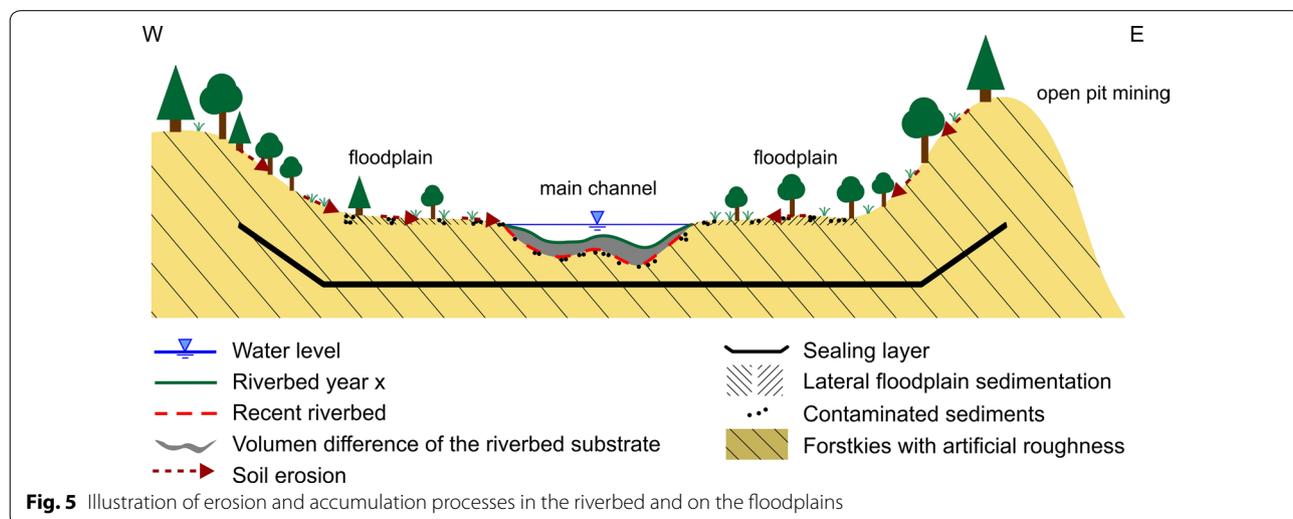
Fig. 5 Illustration of erosion and accumulation processes in the riverbed and on the floodplains

profile of 1 year to the elevation of the same profile of another year (see Fig. 5). When sounding data were missing, which is the case between 2010 AD and 2012 AD, the erosion and sedimentation rates could not be determined for all subdivisions of the new Inde River. The maximum erosion depth of the riverbed was determined by analyzing the distance between the riverbed elevation measured with echo soundings and the sealing layer, which was set as an erosion base during the construction phase. The echo soundings were also used to determine the local erosion of the riverbed and to quantify the potentially hazardous distances to the sealing layer. The maximum depth of erosion was equal to the deepest point of each cross-sectional profile. This depth was compared to the elevation of the sealing layer to determine the minimum vertical distance between the riverbed and the sealing layer.

One hillside, adjacent to the new Inde River at the left bank, almost at the end of the new course (see Fig. 4), showed significant soil erosion contributing to sediment transport. During the construction phase, the ground surface of the hillside was formed using a spreader for coal mining by a wave structure with gullies (see Fig. 6). Rainfall events led to significant hillside erosion through these gullies into the Inde River (see Fig. 5).

The XRF-analyses of four natural surface material samples (Forstkies) show average concentration of 73.19 mg/kg zinc, 21.99 mg/kg lead and 15.76 mg/kg copper. Due to the fact that the composite samples include morphologically active riverbed sediments with higher heavy metal enrichments in the upper part of the 20 cm, their concentration levels are slightly higher but comparable with the geogenic background of the heavy metal contents of the Forstkies samples. Thus, it is concluded that the lower part of the composite samples represents the natural background of the ground surface material (Forstkies), which was used for the construction of the new Inde River. In contrast to the other composite samples, I25 was taken in an accumulated sand bank. Its contents of zinc, lead and copper are comparable to the observations from the sediments that were suspended in the cylinder (method after [40]). Due to the recent formation of the sandbank, this sample does not represent the uncontaminated ground surface material (Forstkies), but an accumulation of surface layer sediments. The heavy metal contents of all the different sediment sample types show that the surface sediments in the whole new riverbed are characterized by enrichments of zinc, lead and copper (see Figs. 5, 13).

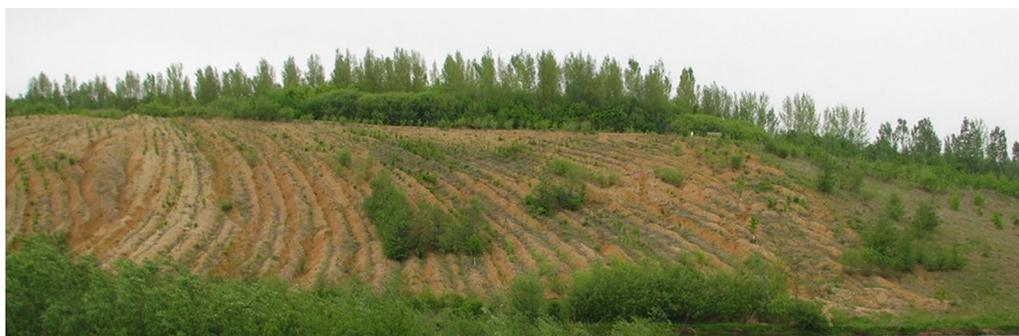
Fig. 6 Wave structure with gullies of the hillside (Photo: IWW, RWTH Aachen)

The amount of hillside erosion was determined by simplifying the gully surface area to two different geometrical structures: (1) a triangle and (2) a half ellipsis (see Fig. 7). The number of erosion gullies was further counted and their depths and lengths were measured, and it was determined if the gullies had a connection to the riverbed or not. Under the assumption that the depth

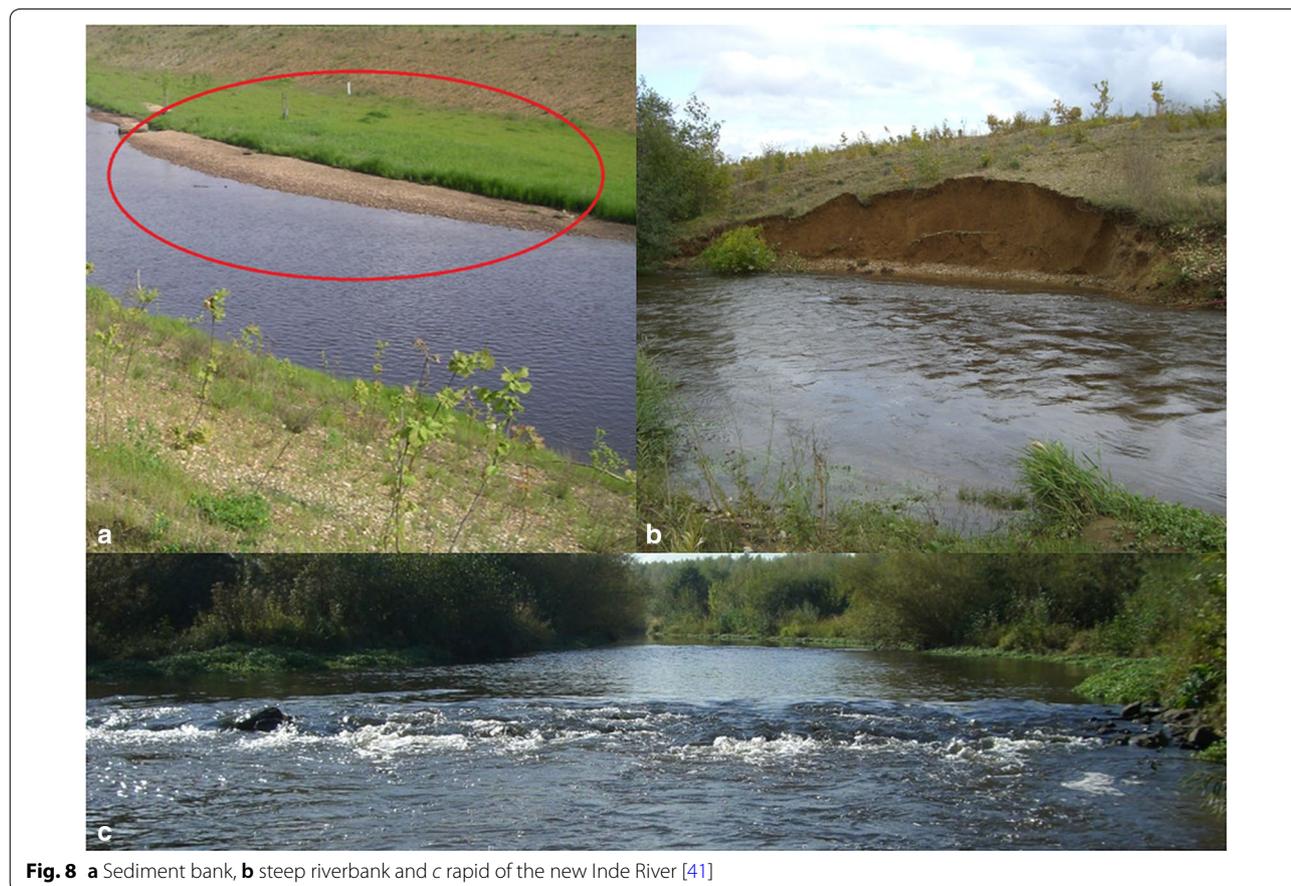
Fig. 8 a Sediment bank, b steep riverbank and c rapid of the new Inde River [41]

Sediment banks develop in areas with low flow conditions [41] (see Fig. 8). The creation of small groynes leads to changes of the main flow direction, which result in cut banks and slip-off banks and a high meander migration potential.

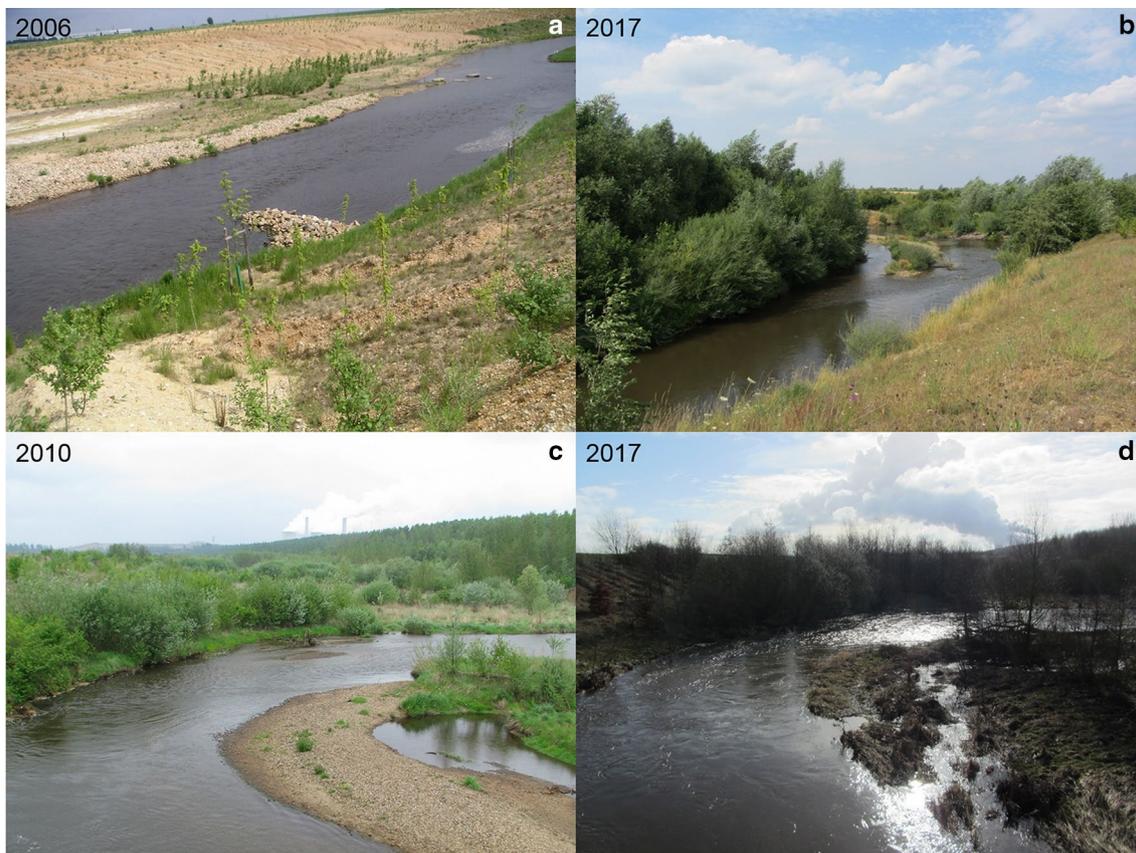
Fig. 9 a, b Comparable river sections. c, d Same river section during low flow conditions and during a flood event (a, c photos IWW, RWTH Aachen; b, d photos PGG, RWTH Aachen)

In 2006 AD, a clear artificial structure of the adjacent hillsides, banks and groynes can be seen. In 2017 AD, the hillsides and the banks and groynes are more overgrown. An accommodated flow diversity is present (see Fig. 9).

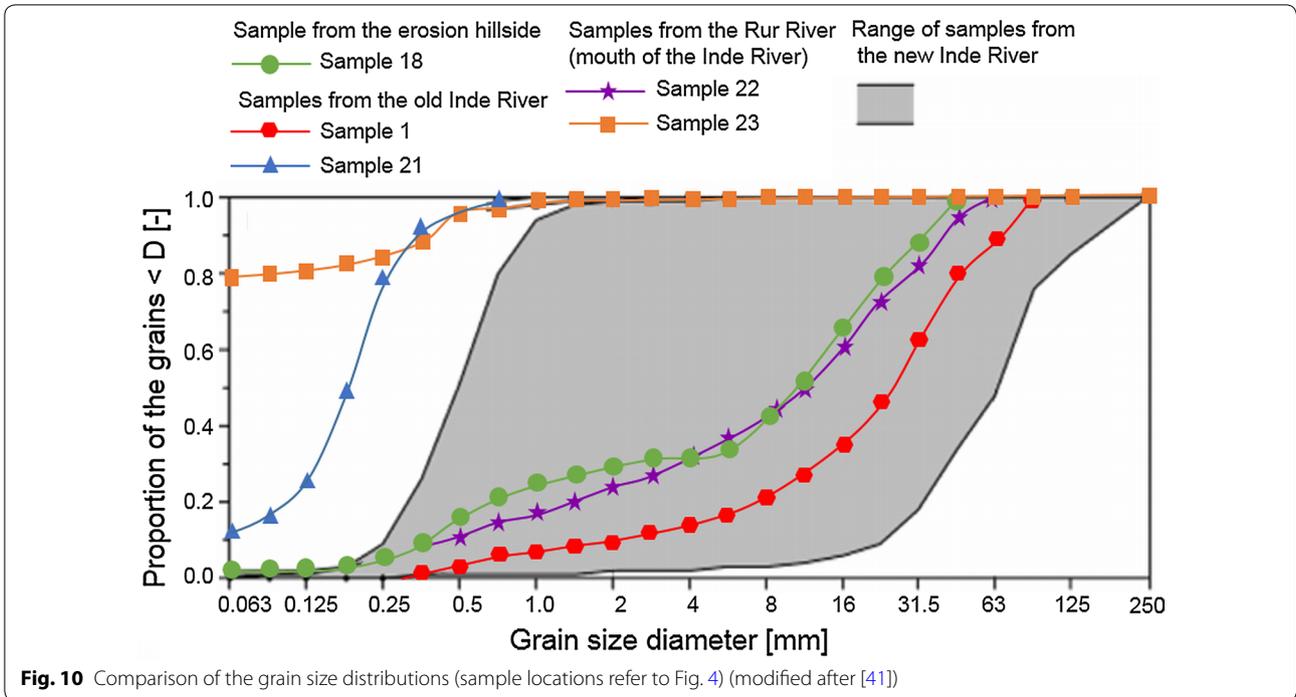
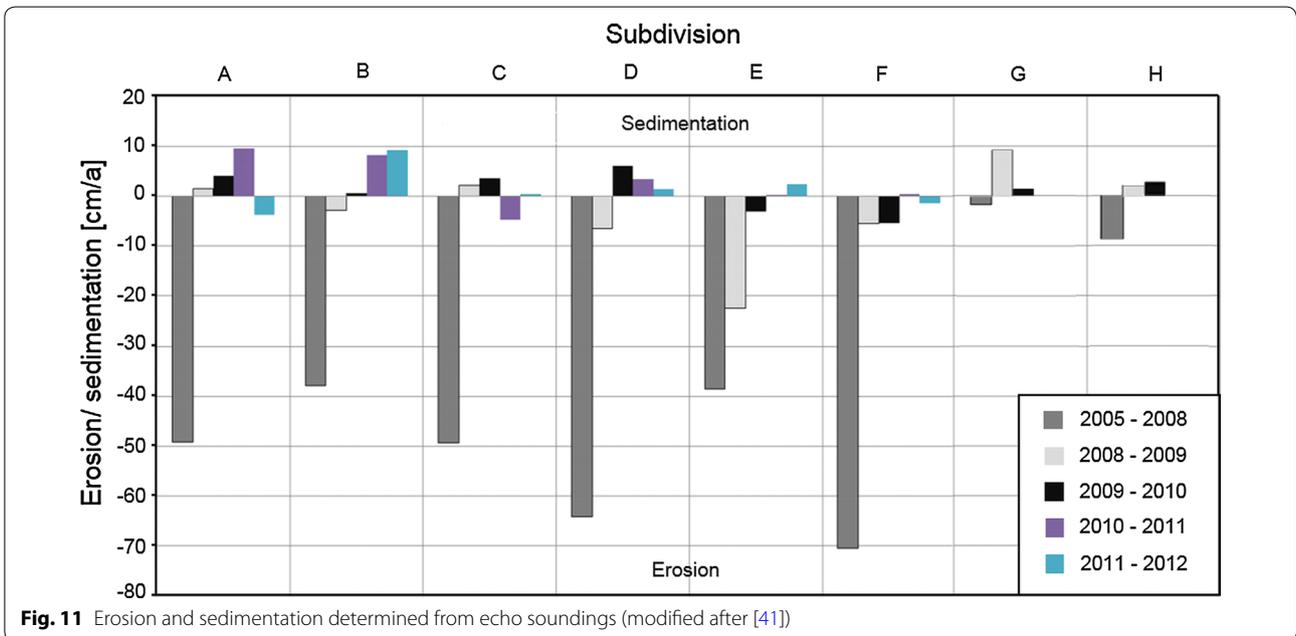
Figure 11 summarizes the amounts of erosion and sedimentation for all subdivisions (A until H, see Fig. 4) of the new Inde River reach. There are no data for subdivisions G and H between 2010 AD and 2012 AD.

Significant erosion took place between 2005 AD and 2008 AD. Many flood events occurred in 2007 AD, followed by an extreme flood event in 2008 AD with a discharge of more than $80 \text{ m}^3/\text{s}$. A flood event with a 100-year flood return interval occurs at discharges of approximately $111 \text{ m}^3/\text{s}$ [36], so that this flood event has a statistically smaller occurrence interval. This sequence of flood events resulted in the erosion of

the riverbed and a high morphological development. Between 2008 AD and 2009 AD, the erosion processes significantly decreased and changed into sedimentation of approx. 400 m³. The analysis of the echo soundings of 2009 AD and 2010 AD shows a low erosion of approx. 300 m³, which even changes to sedimentation, if the dredging of sediment traps 6 and 7 is considered.

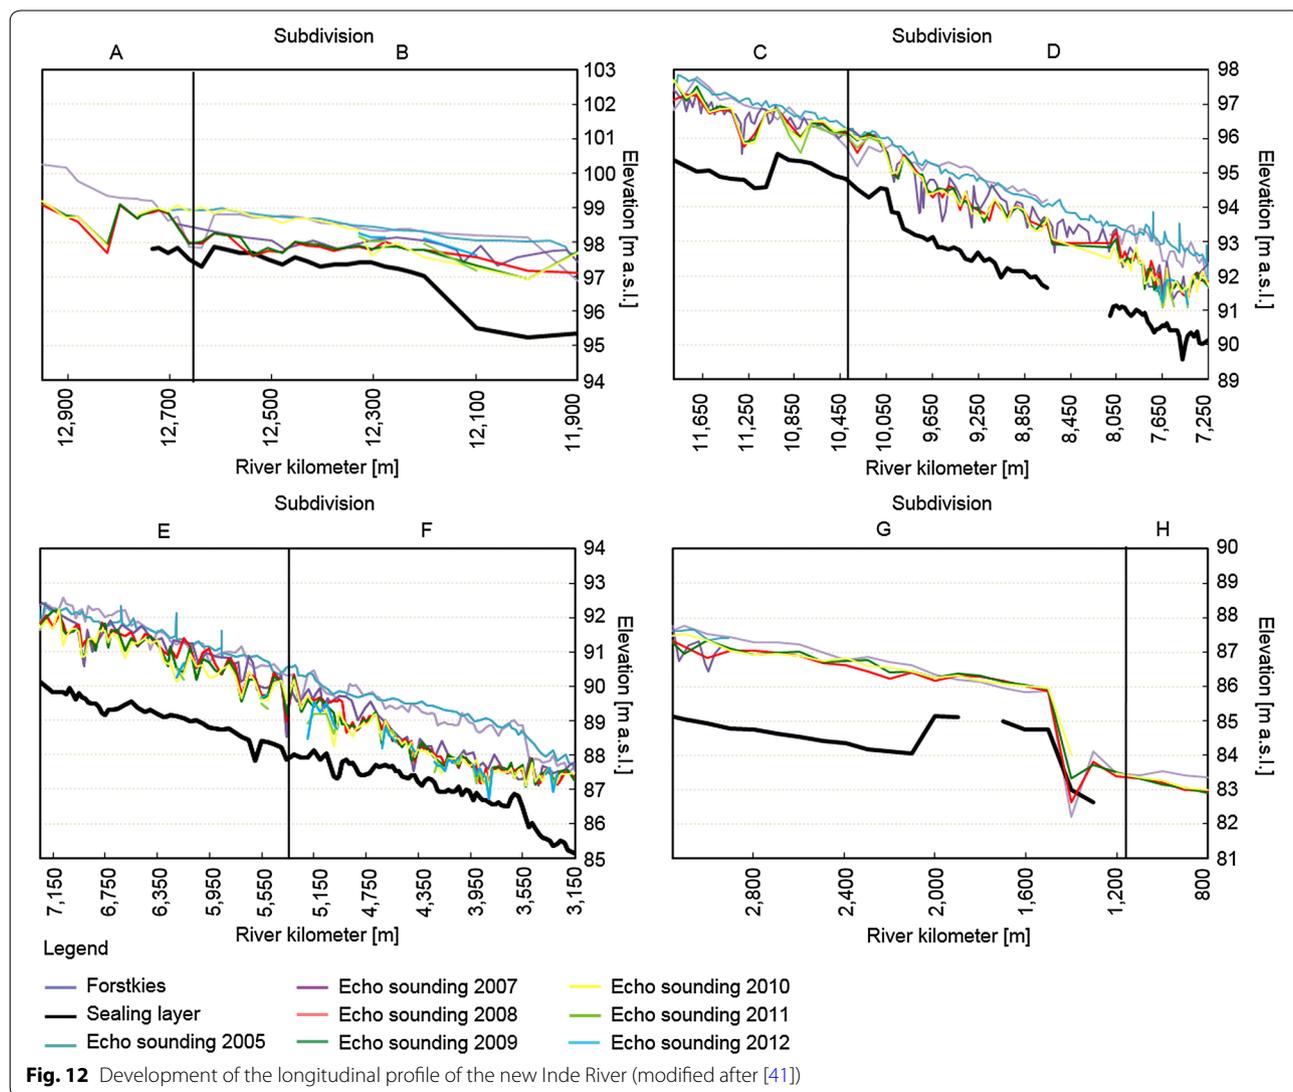
Fig. 12 Development of the longitudinal profile of the new Inde River (modified after [41])

Figure 12 shows the longitudinal profiles of the new Inde River between 2005 AD and 2012 AD based on the deepest point of the echo sounding results of each cross-sectional profile. A comparison of the different riverbed elevations reflects the erosion or sedimentation of the riverbed in the longitudinal directions. The massive erosion of sediment in the downstream direction results in the incision of the riverbed into the ground and a significant sediment input into the Rur River. Despite this incision, the riverbed is still located above the sealing layer, which was installed as a local erosion base during the restoration. The vertical difference in height between two echo sounding data sets is at some locations only a few decimeters (state 2012, see Fig. 12). Only at river km 12.5 did the incision reach the sealing layer in 2008 AD and

2009 AD. Therefore, the sealing layer was repaired locally (see Fig. 12).

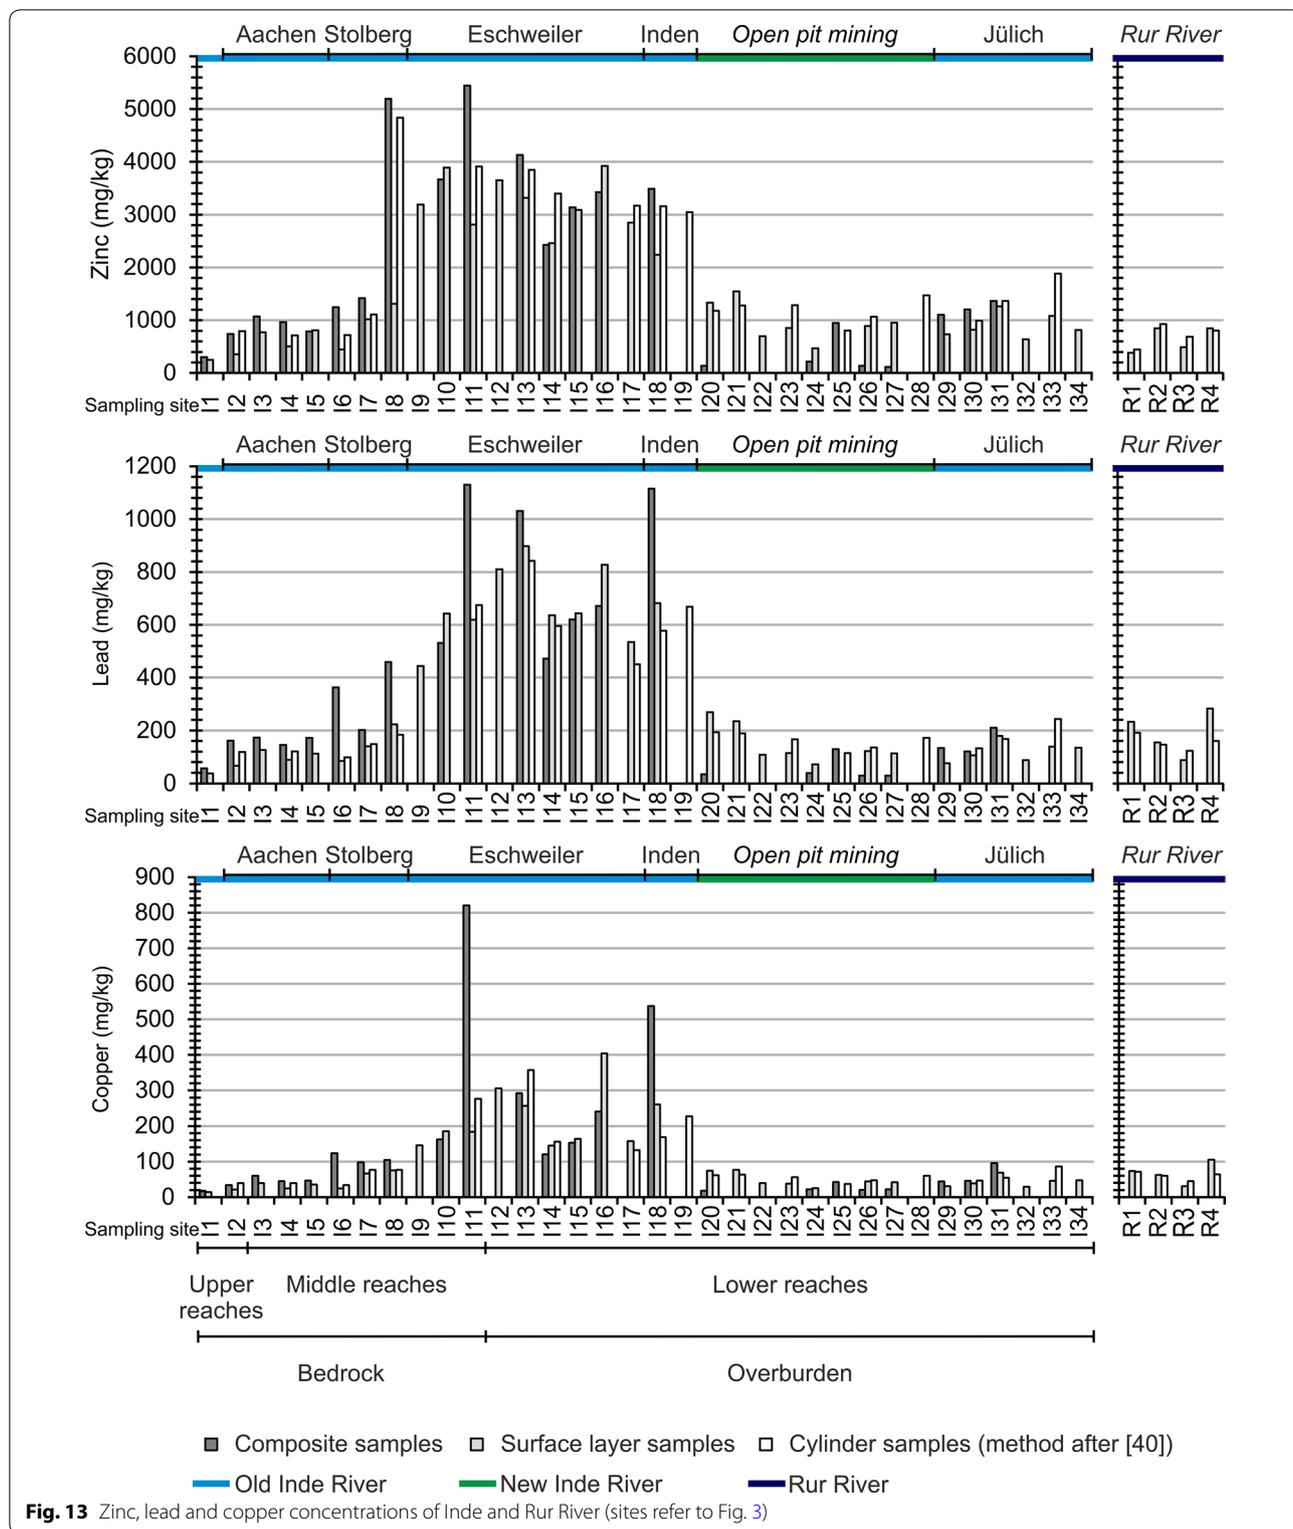
Fig. 13 Zinc, lead and copper concentrations of Inde and Rur River (sites refer to Fig. 3)

Figure 13 shows the concentration profiles for zinc, lead and copper in the sediment samples used as a tracer for a further analysis of the morphological development. In the case of the missing bars, it was either not possible to sample the sediments, or to analyze them because of the grain size limitations of the X-ray fluorescence analysis.

The upper reaches and in part the middle reaches are, besides some past and recent anthropogenic impact factors, mainly characterized by the local geogenic background. There, in the samples of the surface layer, the concentrations of zinc range from 246 up to 1015 mg/kg, the content of lead from 38 to 140 mg/kg and of copper from 14 to 67 mg/kg (see Fig. 13, samples I1–I7).

The sediment samples of the surface layer I8–I18, collected in the middle reaches and in the lower reaches (see Fig. 13), show the highest content levels of the Inde River (Zinc: 3924 mg/kg, see Fig. 13, sample I16; Lead: 898 mg/kg, see Fig. 13, sample I13; Copper: 404 mg/kg, see Fig. 13, sample I16). Stolberg and Eschweiler were influenced by past ore mining and processing and coal mining as well as the iron and steel industry. Historical documents speculate about a beginning of mining in the study area in pre-Roman times. However, mining and ore processing are definitely postulated to have occurred since Roman times. In the sixteenth century, the master copper craftsmen left Aachen due to religious conflicts and moved to Stolberg. The number of brass manufacturing sites, hammer mills and wire manufacturers increased

Even though the heavy metal concentrations of the surface layer samples collected from the new relocated riverbed (last part of the lower reaches, see Fig. 13, samples I20–I28) are significantly lower than those in the middle reaches and in parts of the lower reaches (see Fig. 13, samples I8–I19), they are higher compared to the concentrations analyzed in the samples collected in the upper reaches and partly in the middle reaches (see Fig. 13, samples I1–I7).

The surface layer sediments of the new riverbed show higher heavy metal contents than the composite samples of the upper 20 cm (see Fig. 13, samples I20–I28). An exception is the composite sample I25.

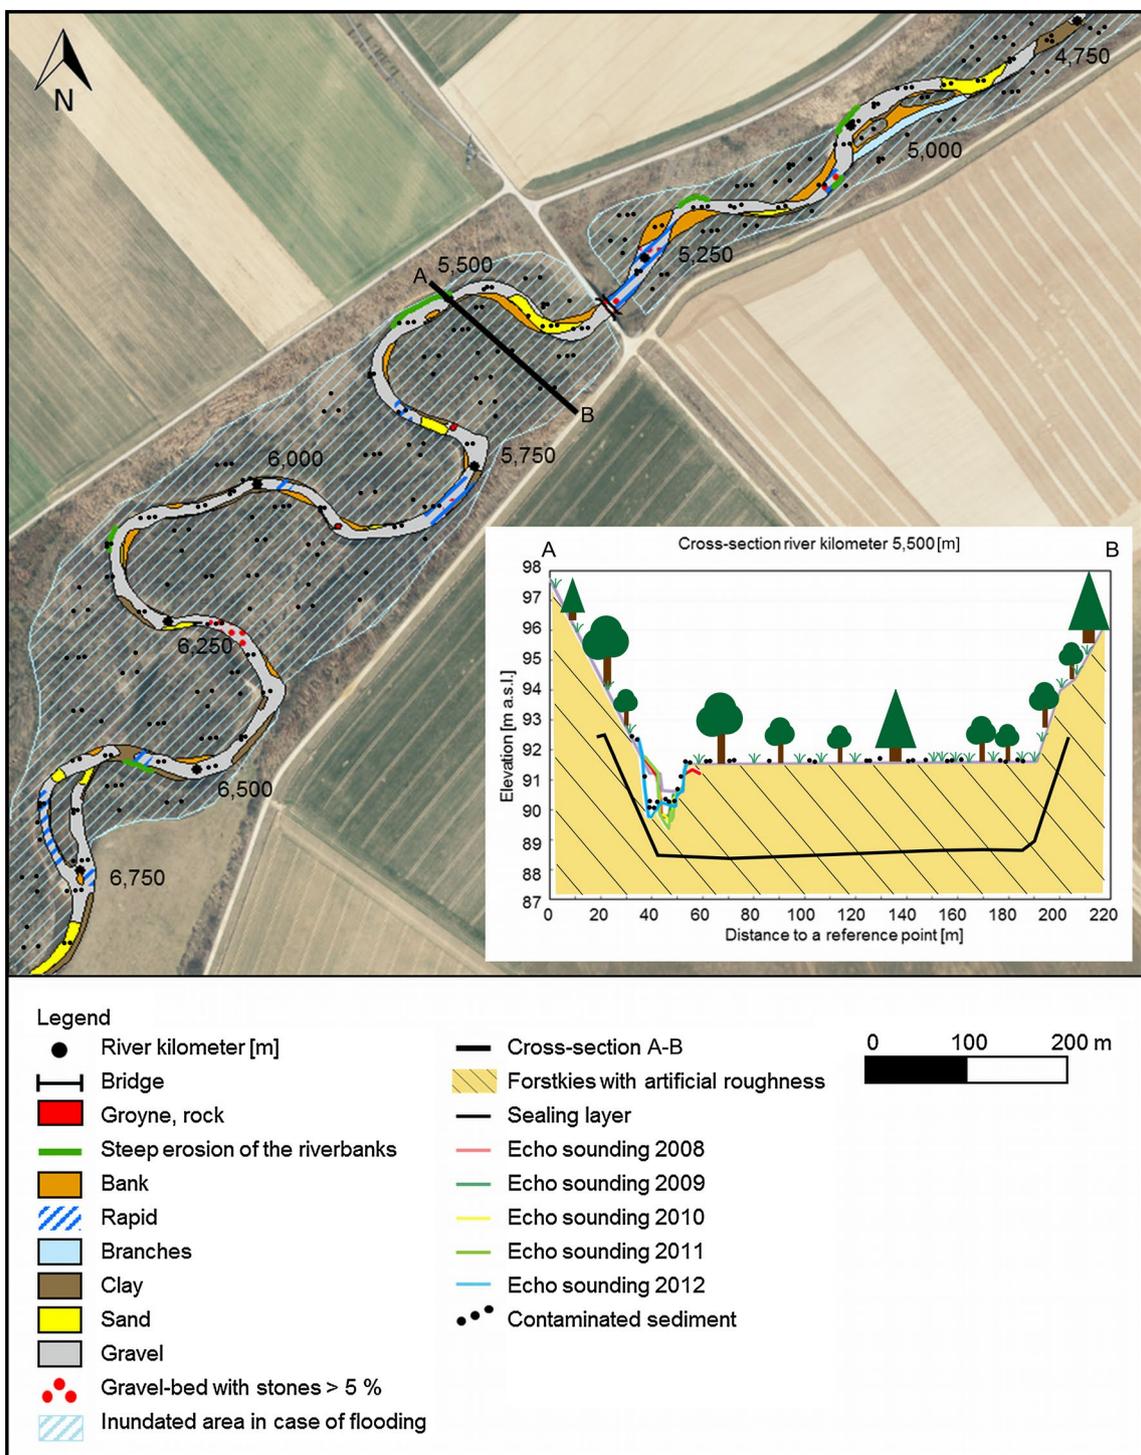
Fig. 14 Fluvial morphodynamics of the new Inde River from the top view and an example cross-section
